EXTERIOR WALL INSPECTION REPORT  
OUR LADY OF THE ASSUMPTION CATHOLIC CHURCH

35 OLD EAGLE SCHOOL ROAD  
STRAFFORD , PA 19087

JULY 31, 2017

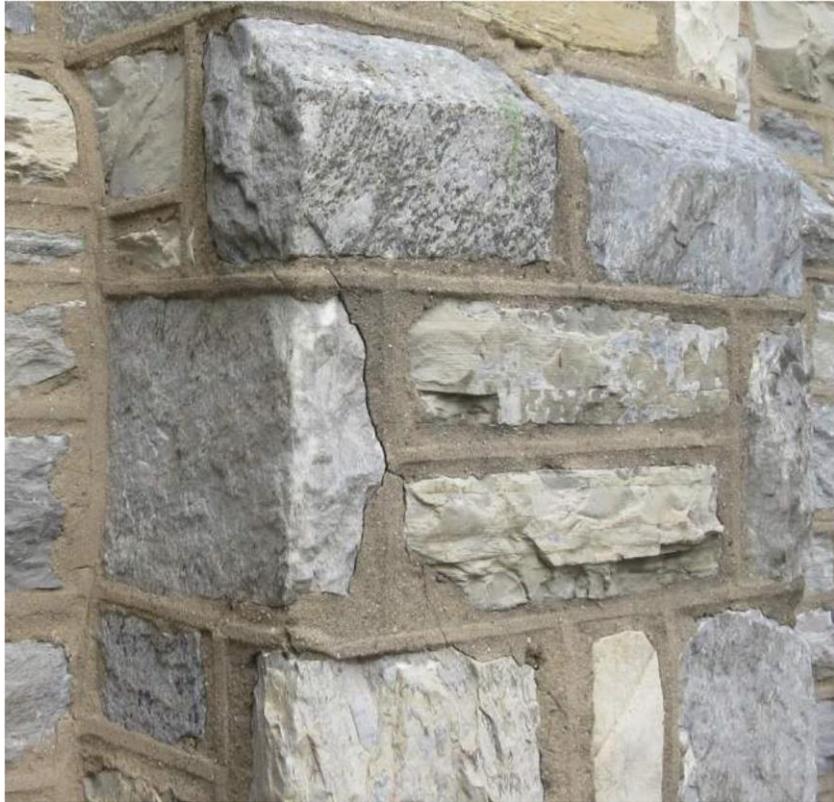
***Cracked mortar joints in granite masonry at East elevation.***

*Recommendation:* Deteriorated mortar joints should be cut and repointed within the next 2-4 years to prevent accelerated masonry deterioration. The stucco façade at the pedestrian stairs should be removed and repaired within the next year to prevent development to an unsafe condition.

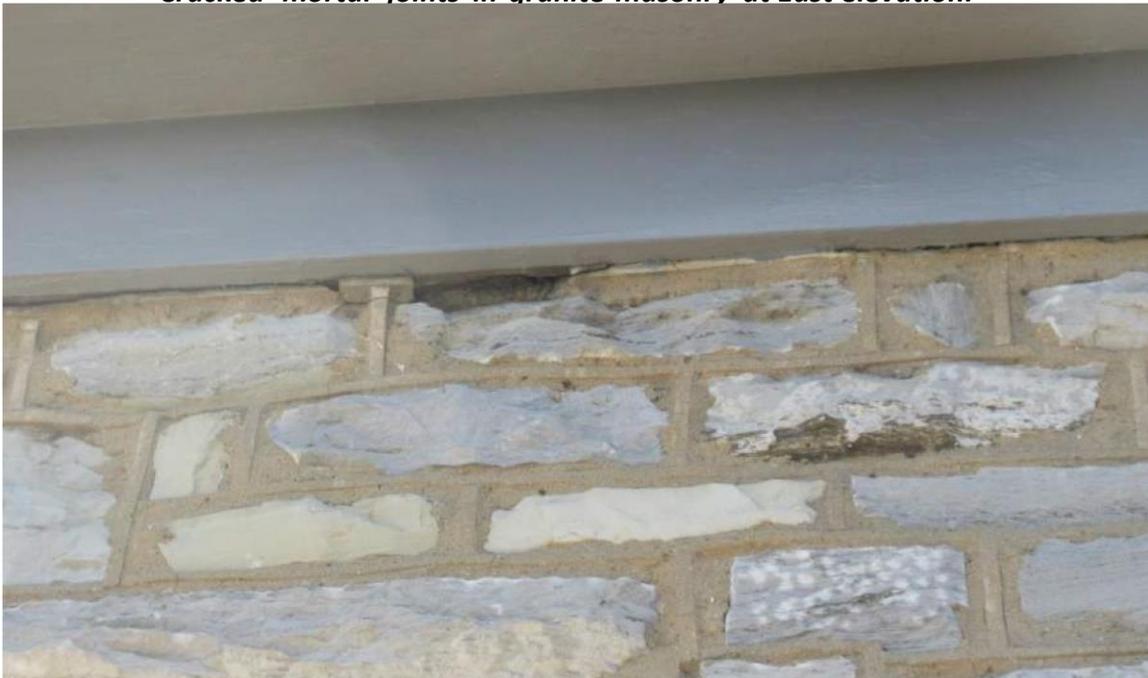
***Typical deterioration of mortar joints in masonry.***

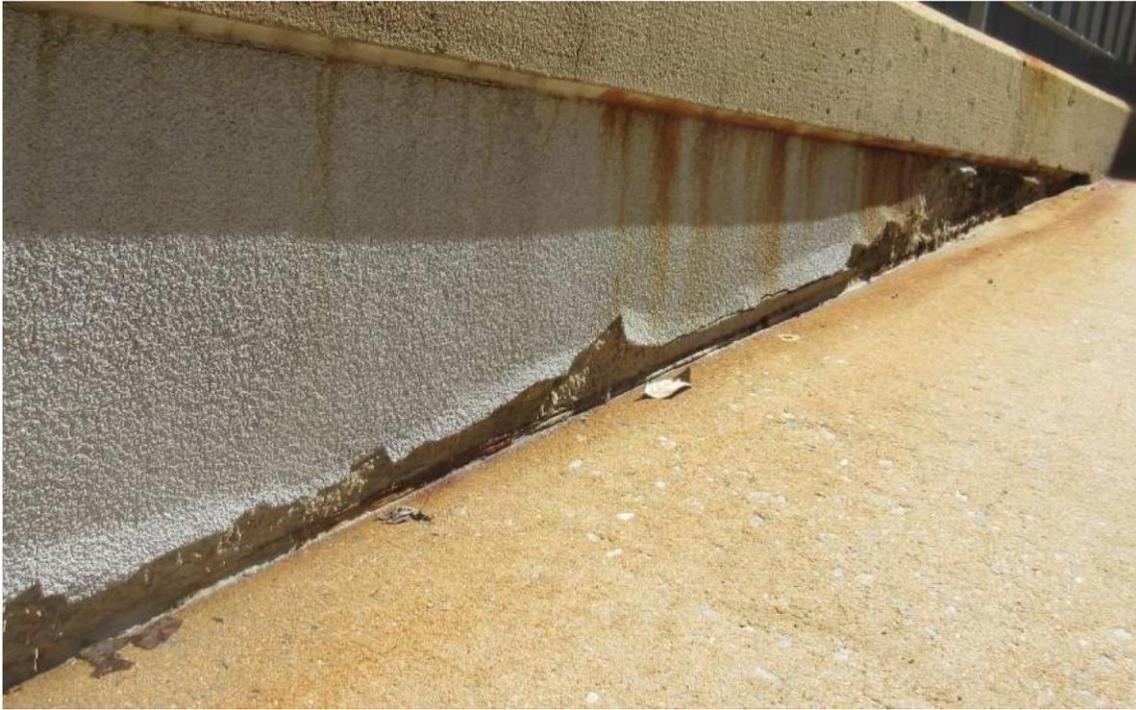
***Spalling stucco at pedestrian ramp, South elevation.***

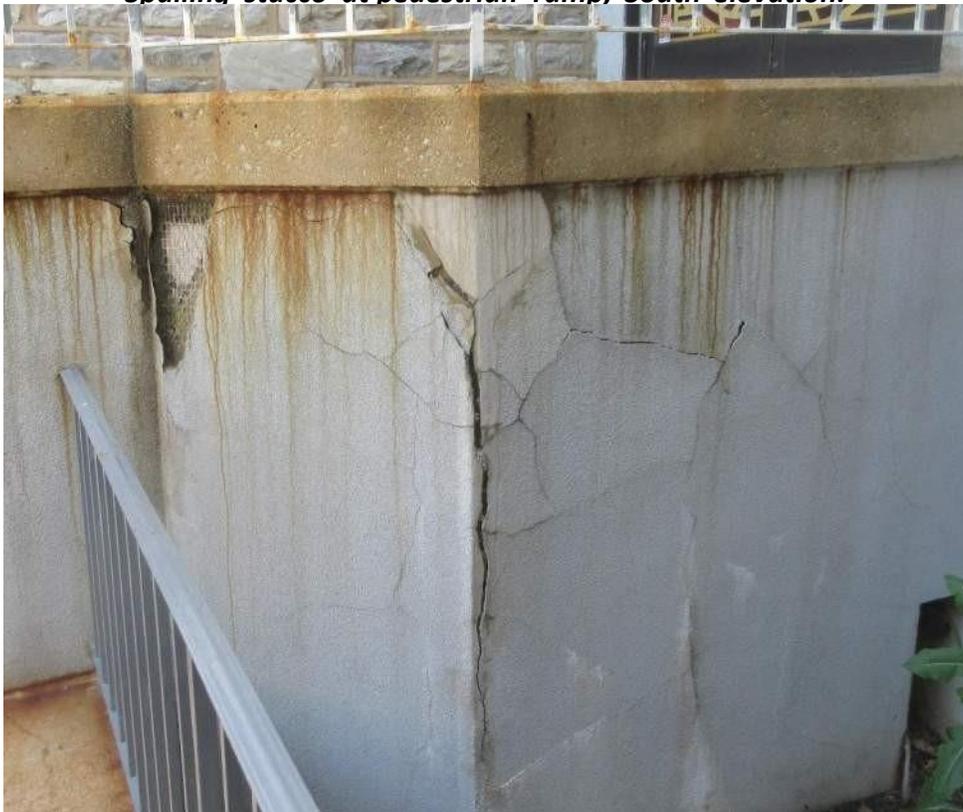
***Cracked and spalling stucco at pedestrian ramp, South elevation.***

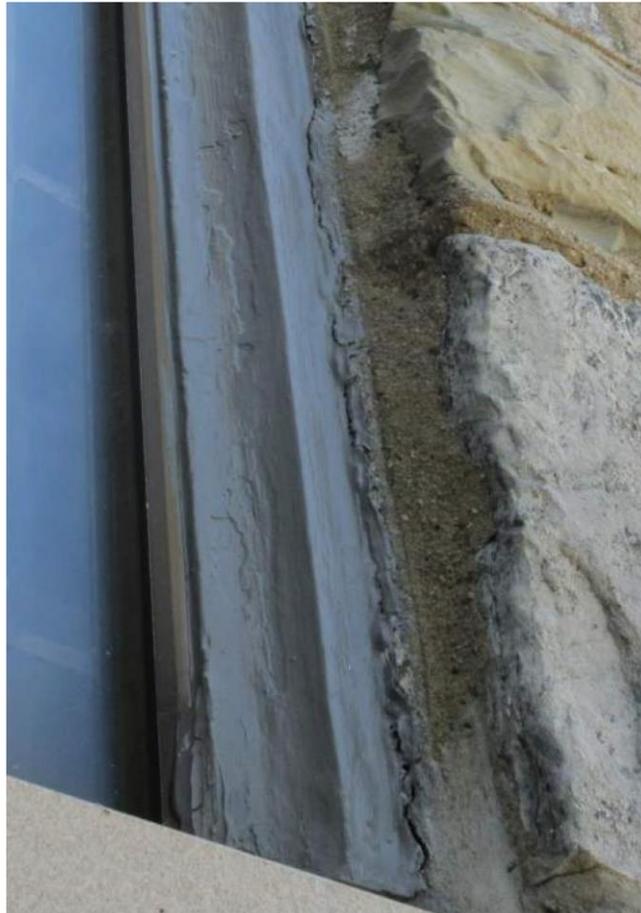
***Typical failing sealant around windows.***

*Recommendation:* Window sealant should be removed and re-sealed within the next 2-4 years to maintain the water tightness of the building. O&S recommends that the parish perform a wood window painting program in the next 5-10 years to extent the service life of the wood frames.

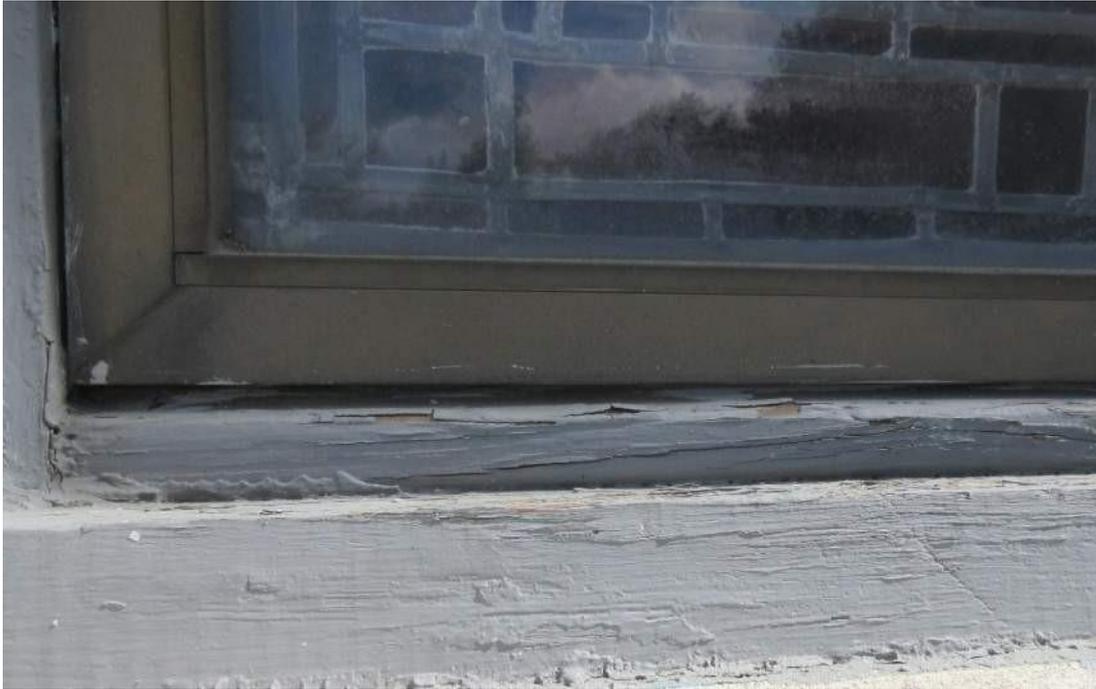
***Typical peeling paint on wood window frame.***

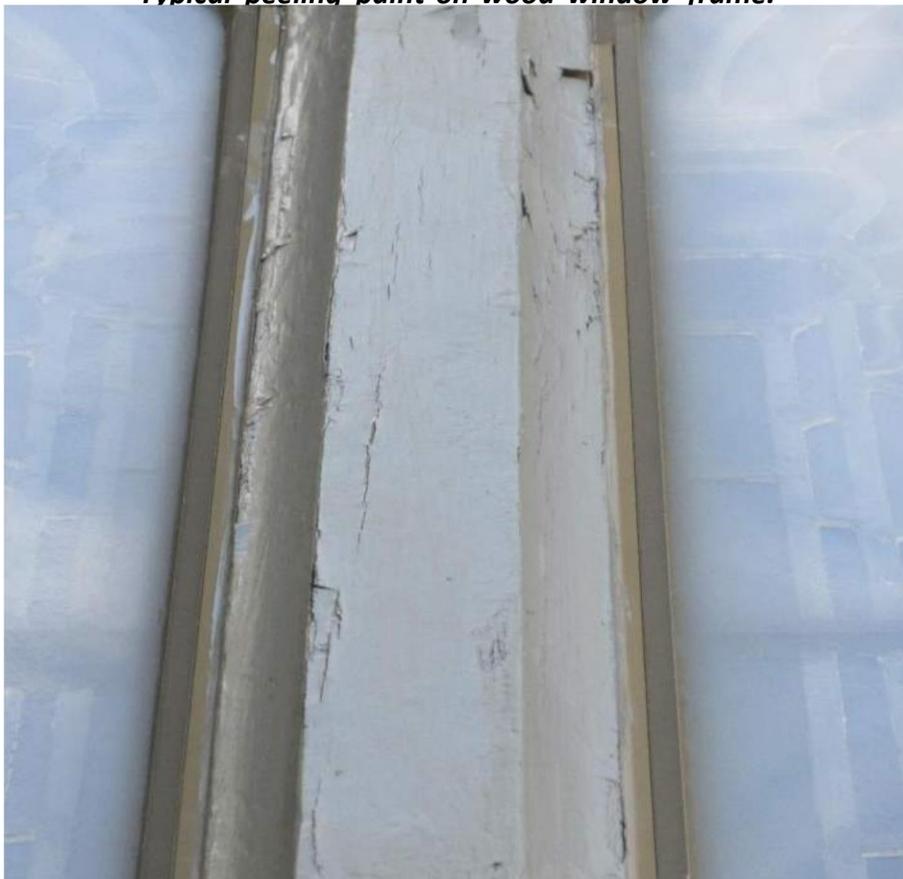
***Typical peeling paint on wood window frame between stained glass windows.***

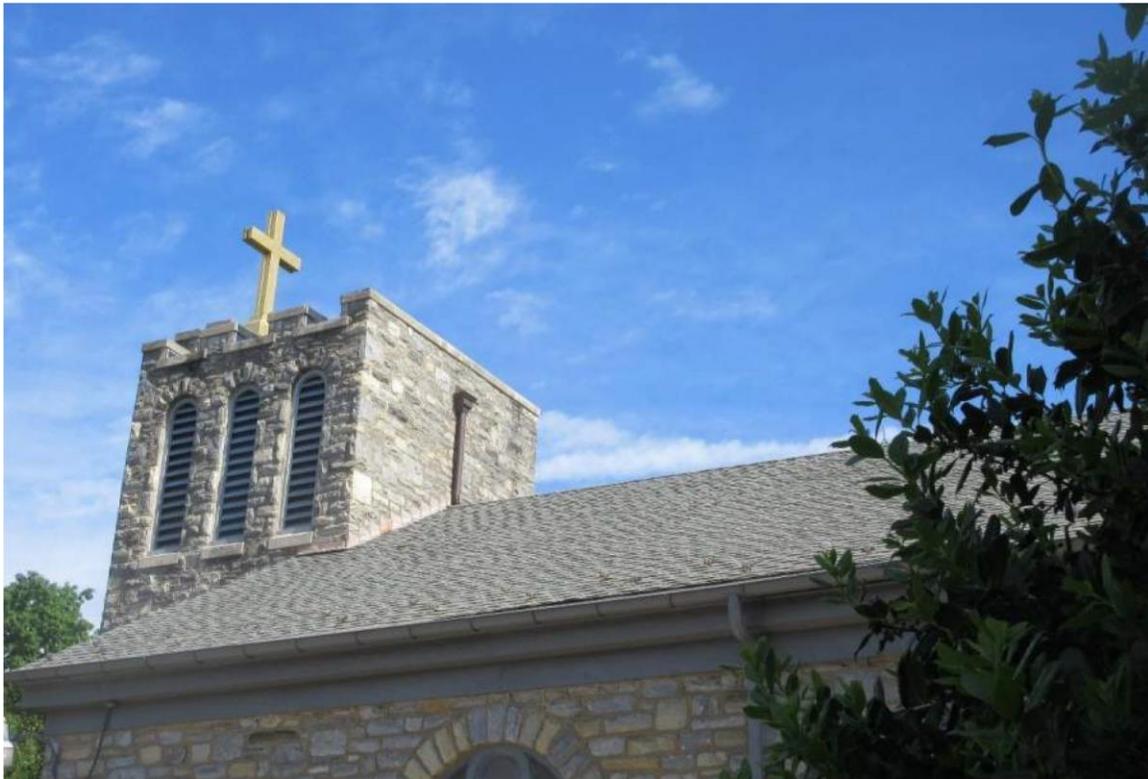
***General view of the asphalt shingle roofing.***

*Recommendations:* O&S recommends the parish perform an annual roofing review to repair damage and to extend the service life of the roofing assembly.

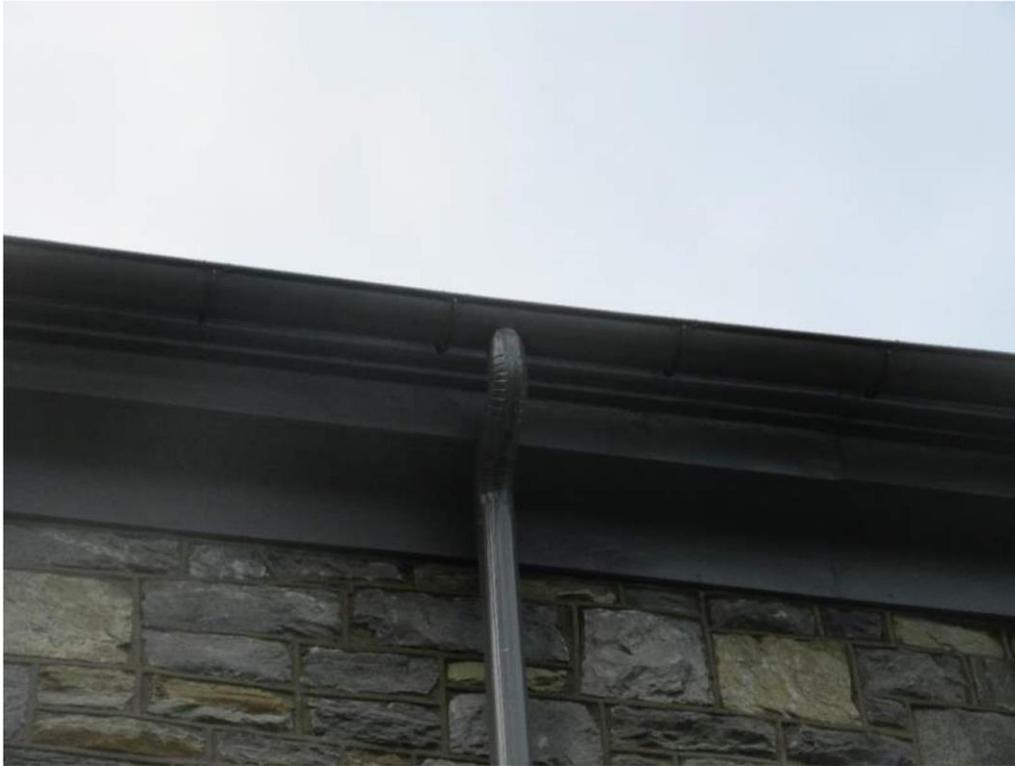
*Typical view of the metal gutters and downspouts.*

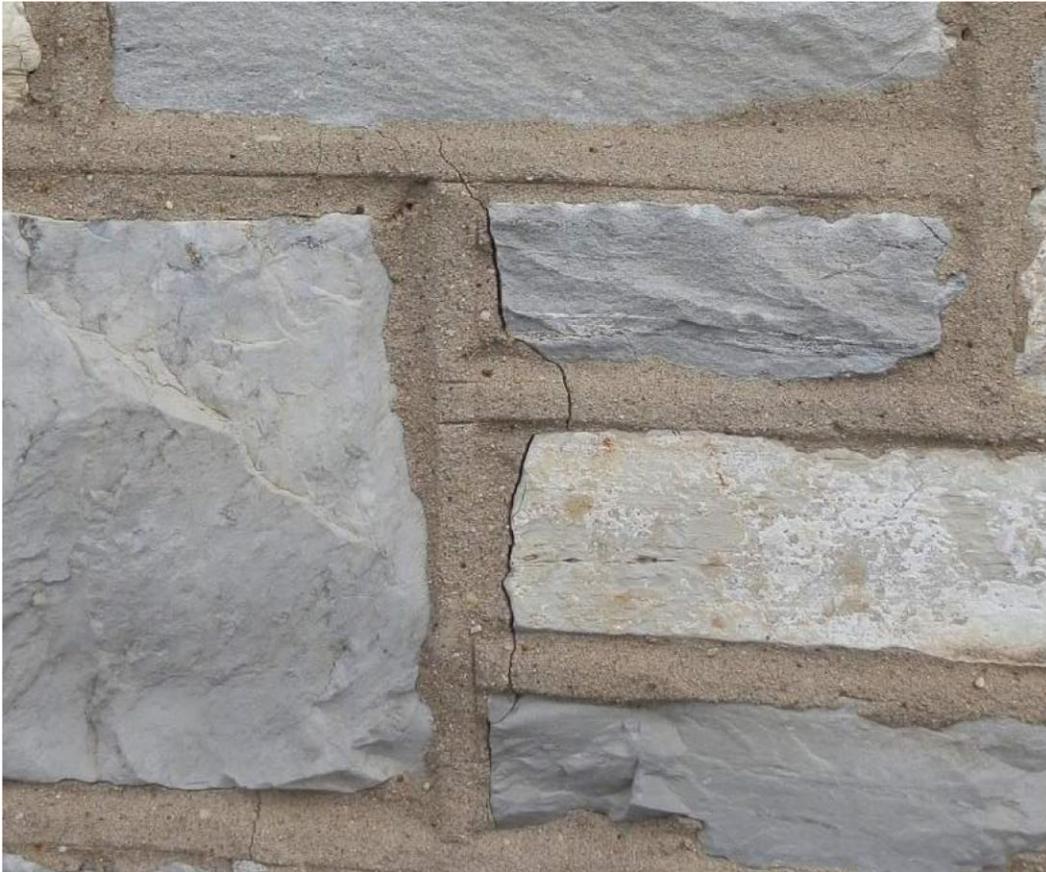
***Typical cracked mortar joints in granite masonry.***

*Recommendations:* Deteriorated mortar joints should be cut and repointed within the next 2-4 years. Cracked granite masonry should be repaired by crack injection within the next 2-4 years. Cracked stucco should be removed and repaired within the next year to limit the potential for moisture infiltration into the wall assembly. Loose metal flashing

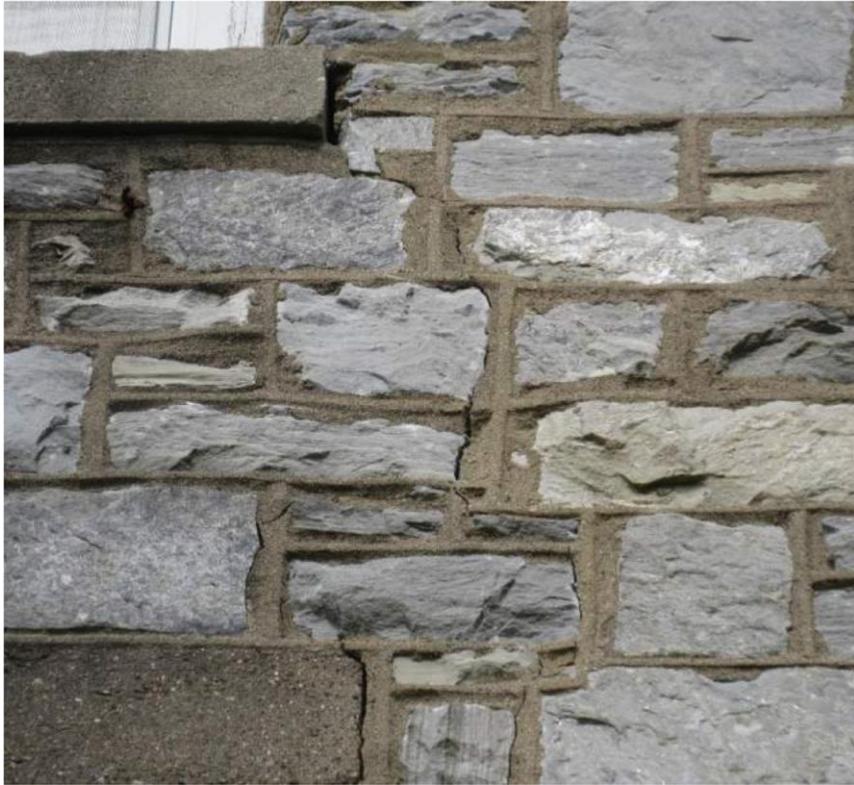
***Cracked mortar joints in granite masonry between windows at East elevation.***

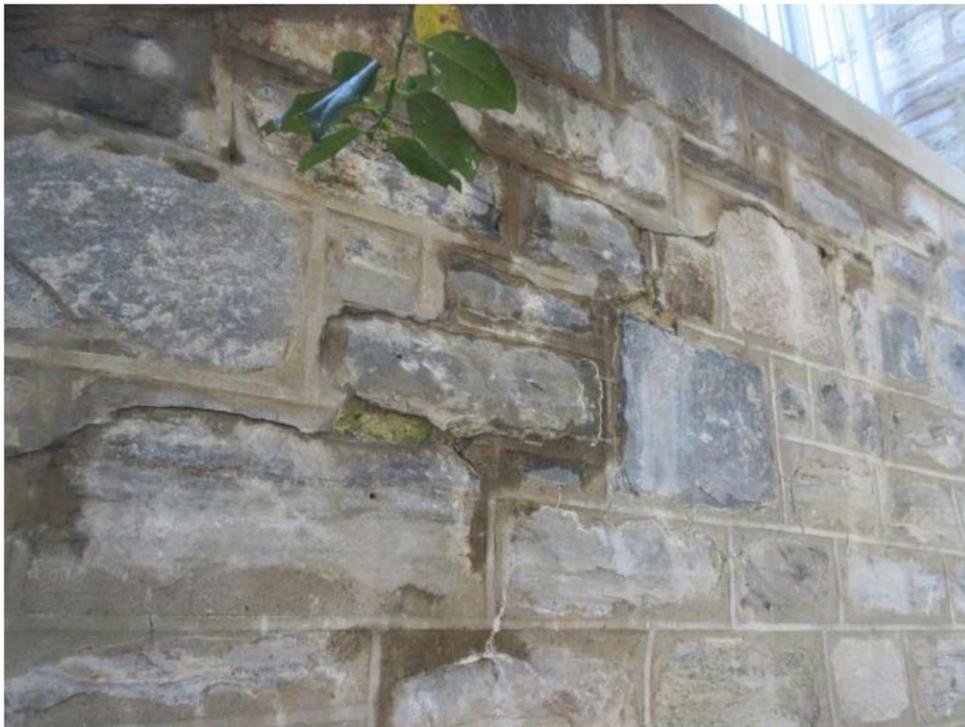
***Deteriorated masonry joints at stair wall, West elevation.***

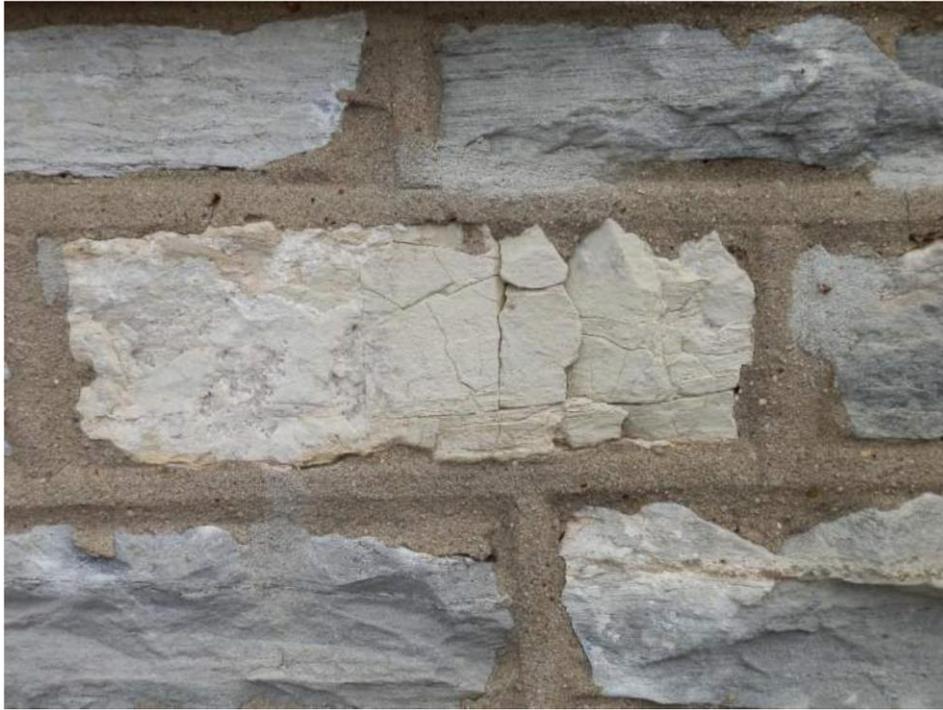
***Cracked granite masonry at South elevation.***

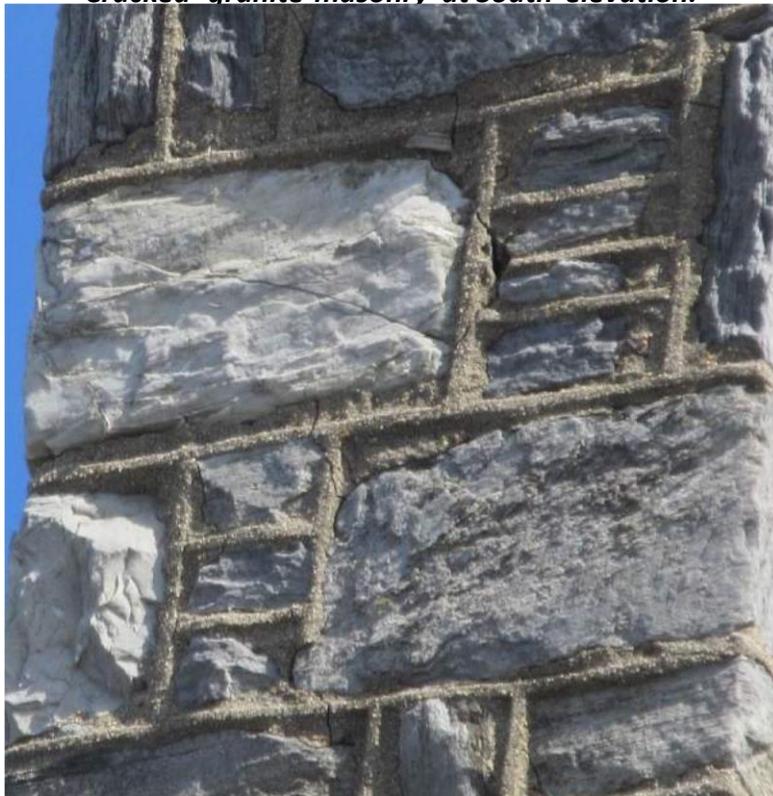
***Cracked granite masonry and mortar joints at chimney.***

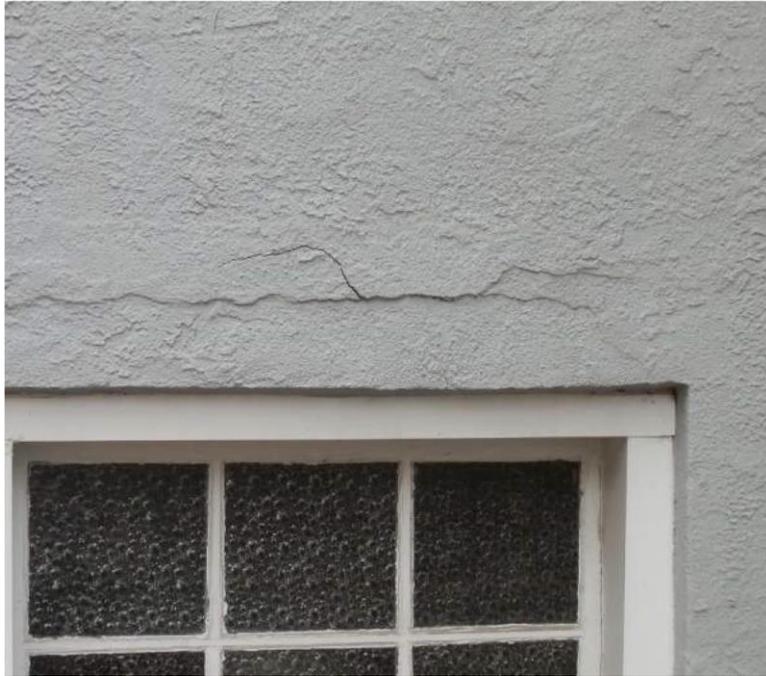
***Cracked stucco above window at West elevation of connecting structure between Church and Rectory buildings.***

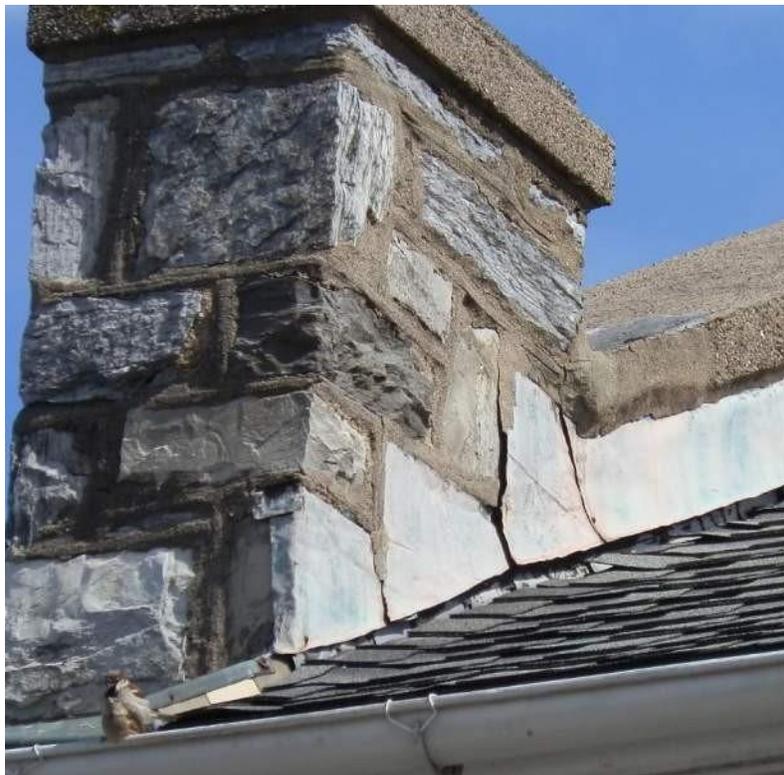
***Loose metal flashing at roof, near South-west building corner.***

should be repair within the next year to prevent moisture infiltration into the interior of the building. All rotted and damaged wood elements should be replaced within the next year. O&S recommends the parish complete a wood painting program at the rectory within the next 2-4 year to prolong the useful life of the wood trim elements. The window perimeter sealant joints should be replaced within the next year to prevent moisture infiltration into the wall assembly. Cracked and incipient spalls in the concrete lintels and sills should be repaired within the next year to prevent the possibility of overhead spalling. The damaged window screen should be removed and replaced in kind within the next 5-10 years.

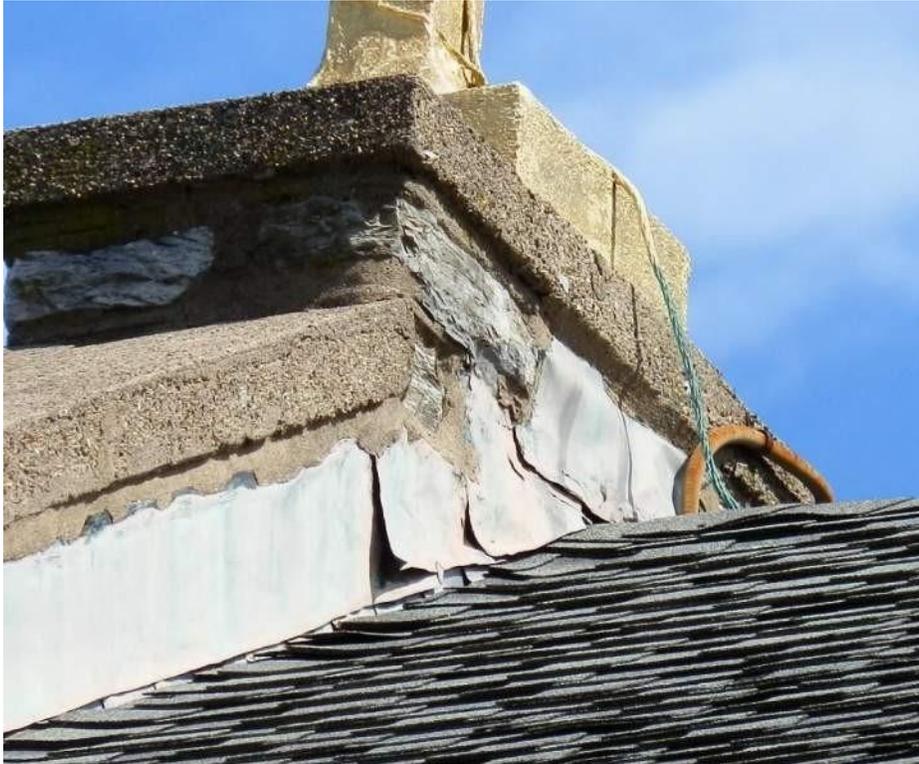
***Loose metal flashing at roof, middle of West side.***

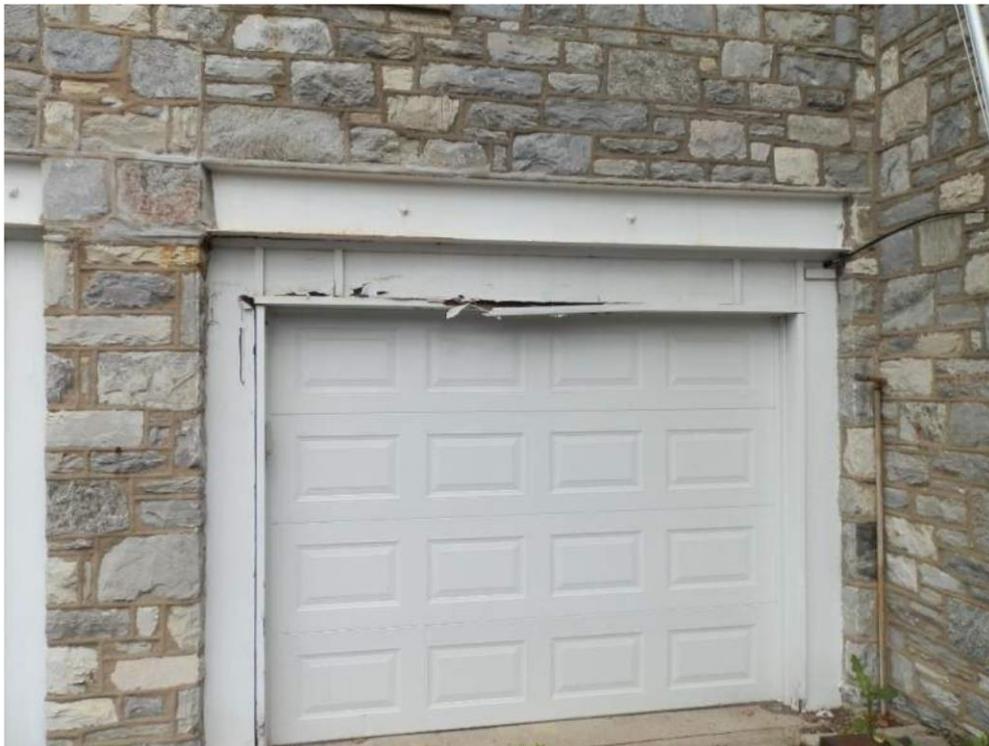
***Deteriorated wood frame around garage door at East elevation.***

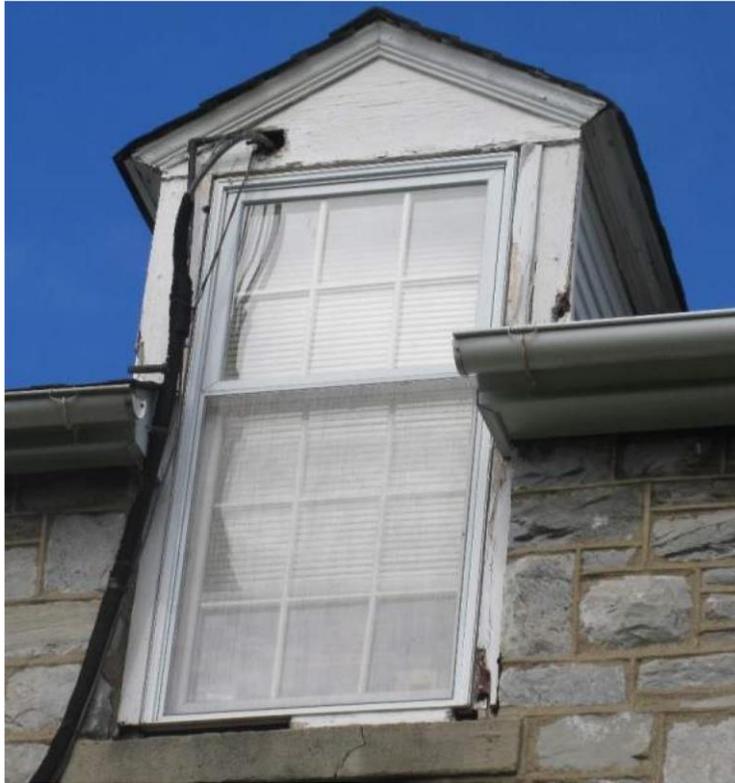
***Typical deteriorated wood around third-story windows. Note cracked concrete sill, East elevation.***

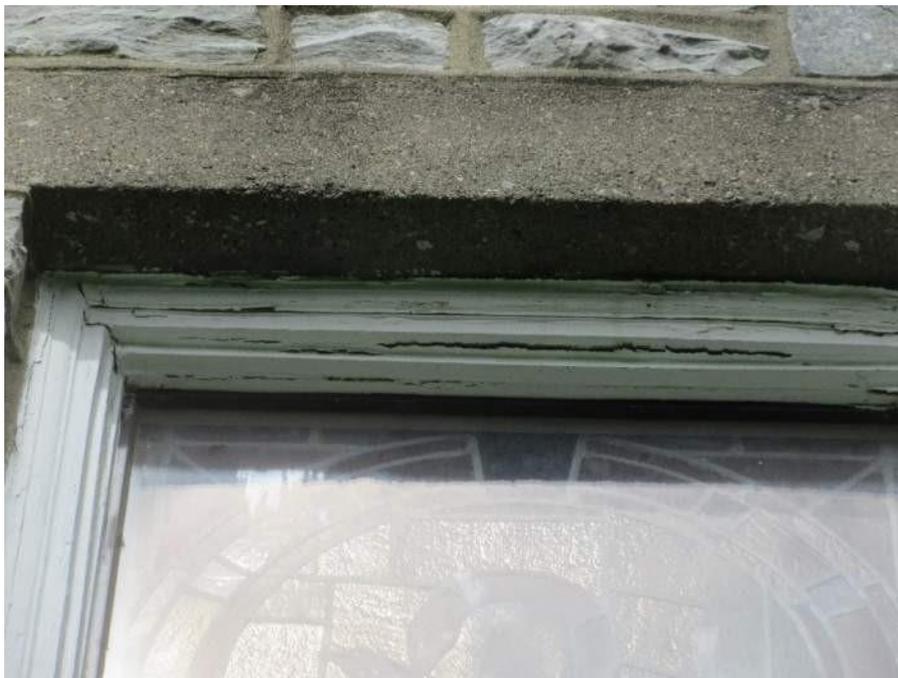
***Typical cracked wood window frame around stained-glass window.***

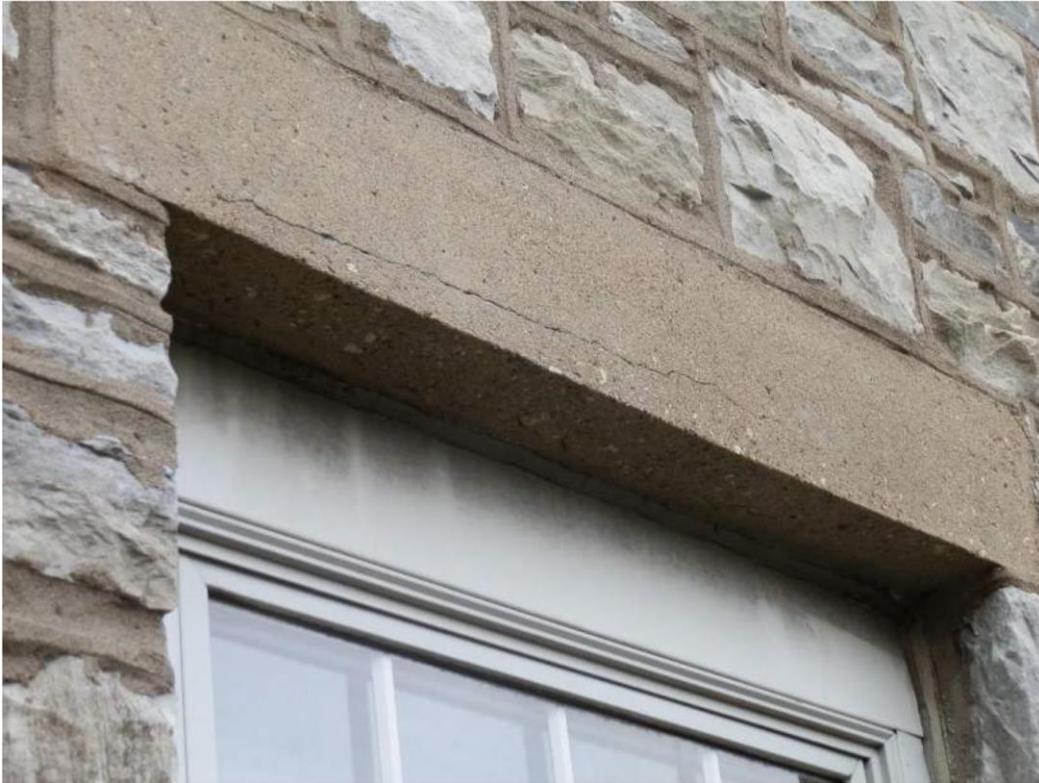
***Cracked concrete lintel at window, West elevation.***

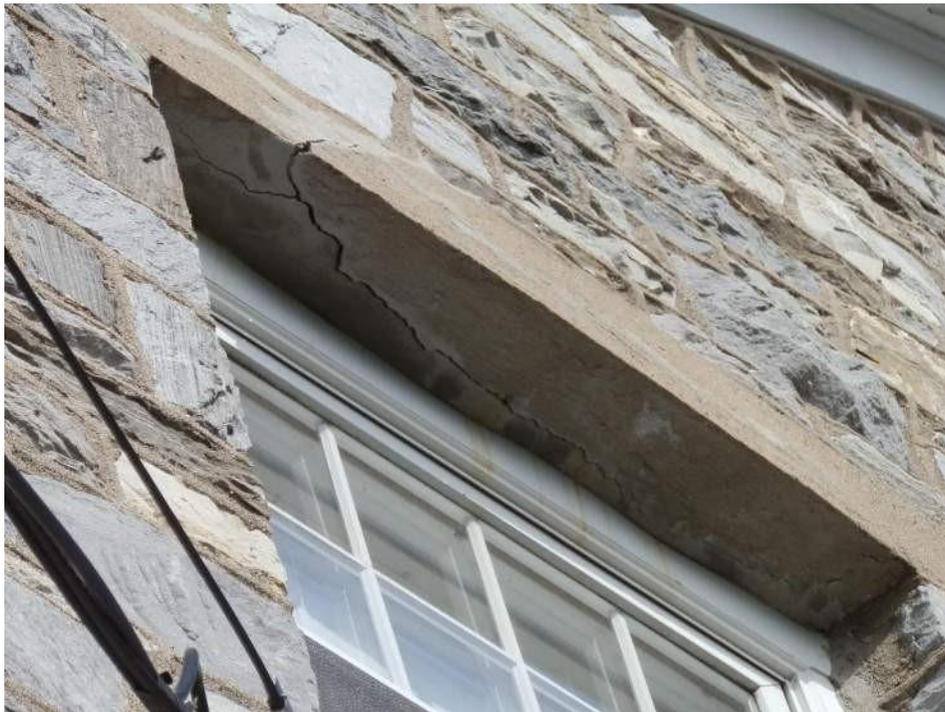
***Cracked and incipient spall in concrete lintel at third-story, East elevation.***

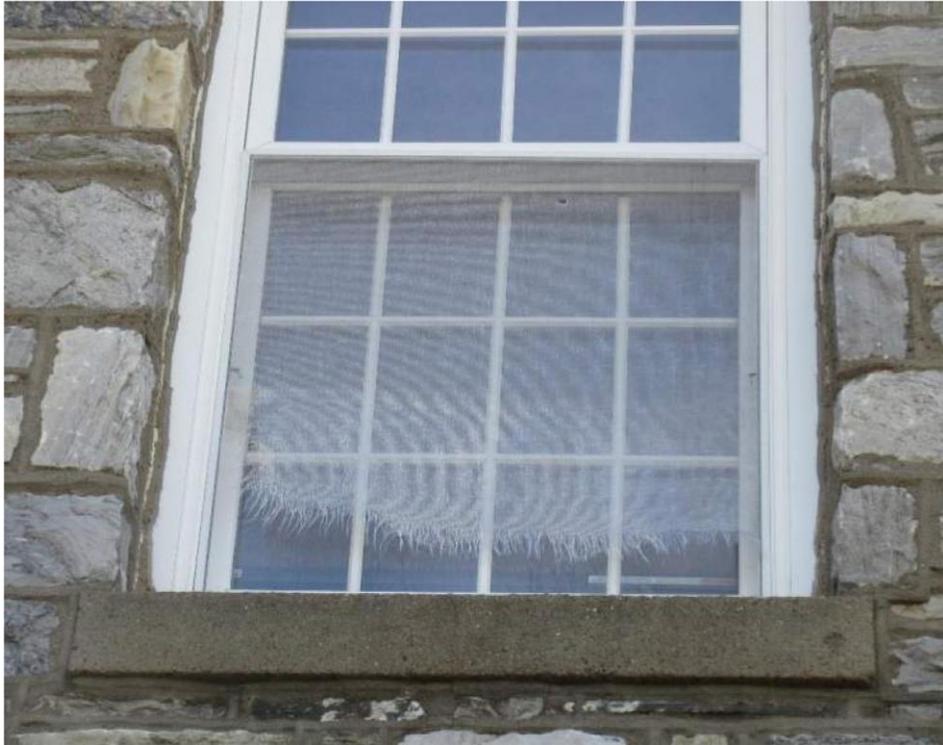
***Damaged screen at second-story middle window, West elevation.***

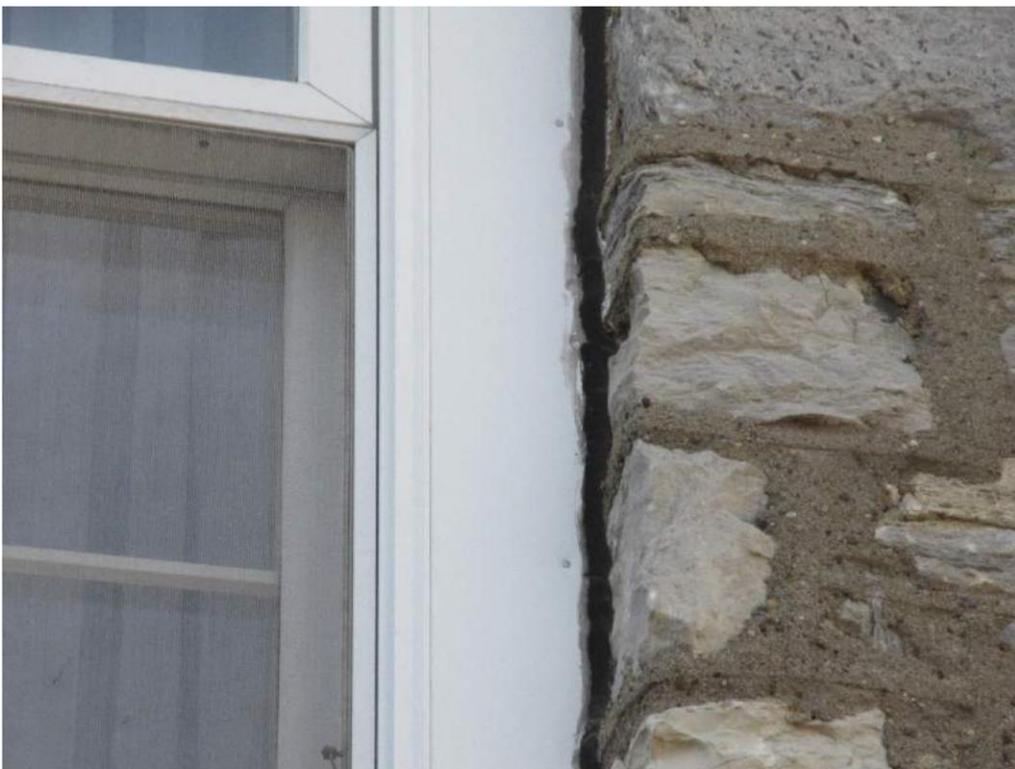
***Missing and open window perimeter joints at vinyl windows.***

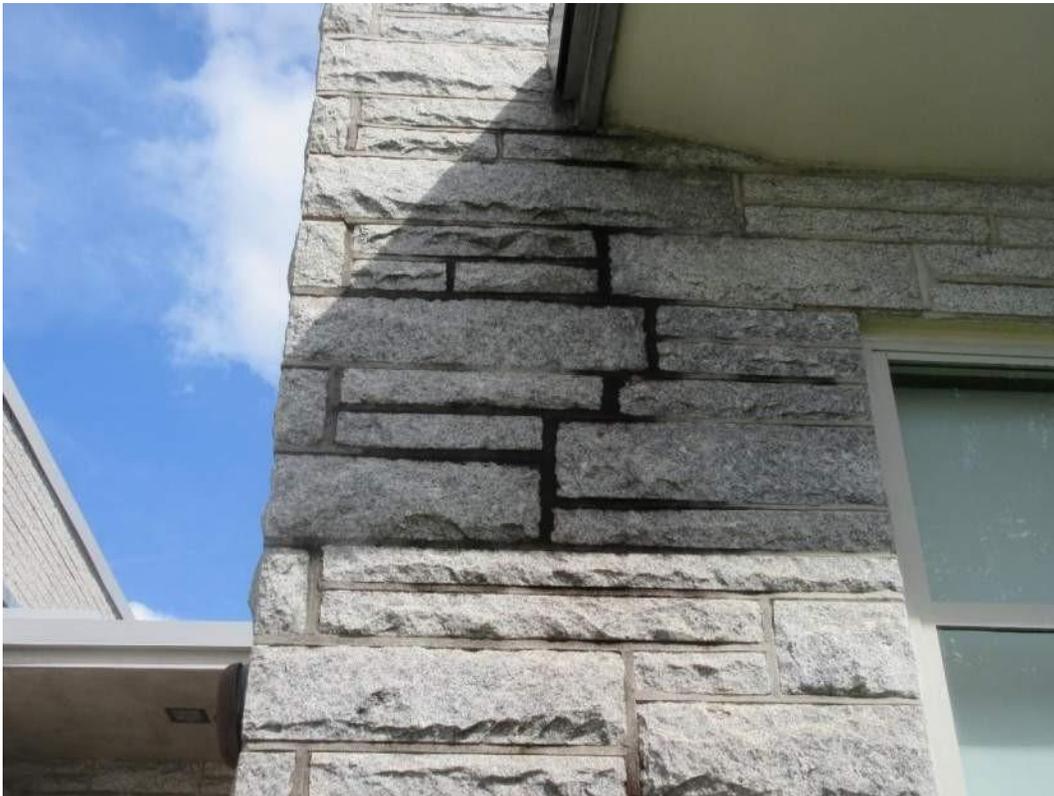
***Weather masonry joints in granite masonry at South elevation.***

**Recommendation:** Deteriorated joints in granite masonry should be cut and repointed within the next 2-4 years. The cracked granite should be repaired within the next year to prevent accelerated masonry deterioration. All cracks in the soffit should be routed and sealed within the next 2-4 years. All window sealant should be removed and replaced within the next 2-4 years to maintain the water tightness of the building. The metal door at the North elevation should be replaced within the next 2-4 years. O&S recommends the parish have an annual roofing inspection to maintain the serviceability of the roofing membrane.

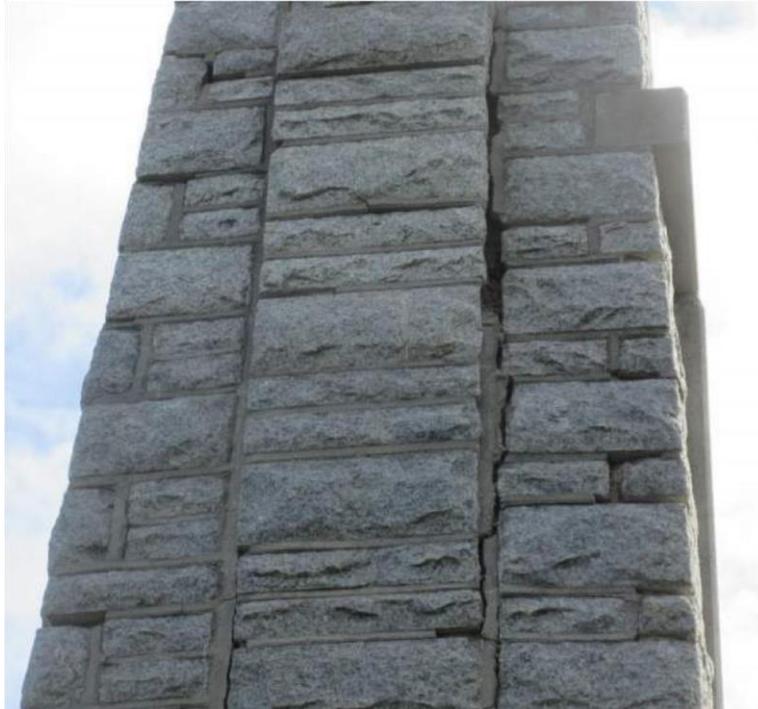
***Cracked masonry joints, typical, on granite masonry pillar at South elevation.***

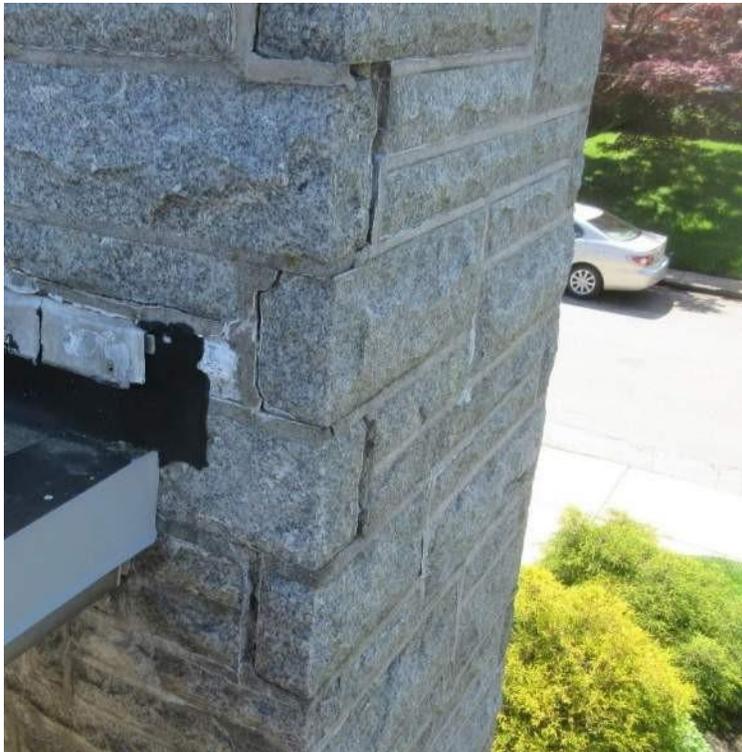
***Cracked masonry joints, typical, on granite pillar at South elevation.***

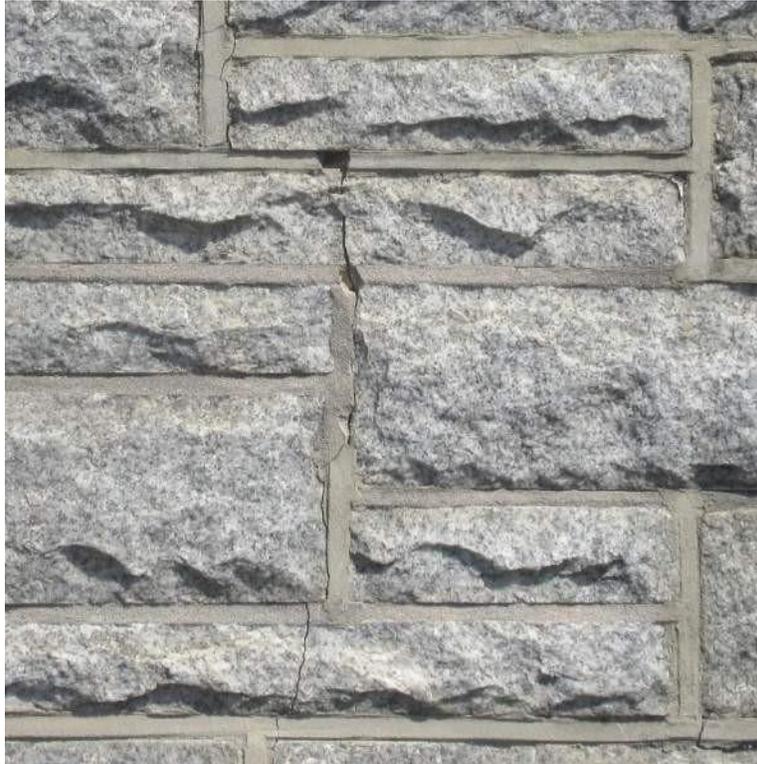
***Cracked granite masonry on pillar at South elevation.***

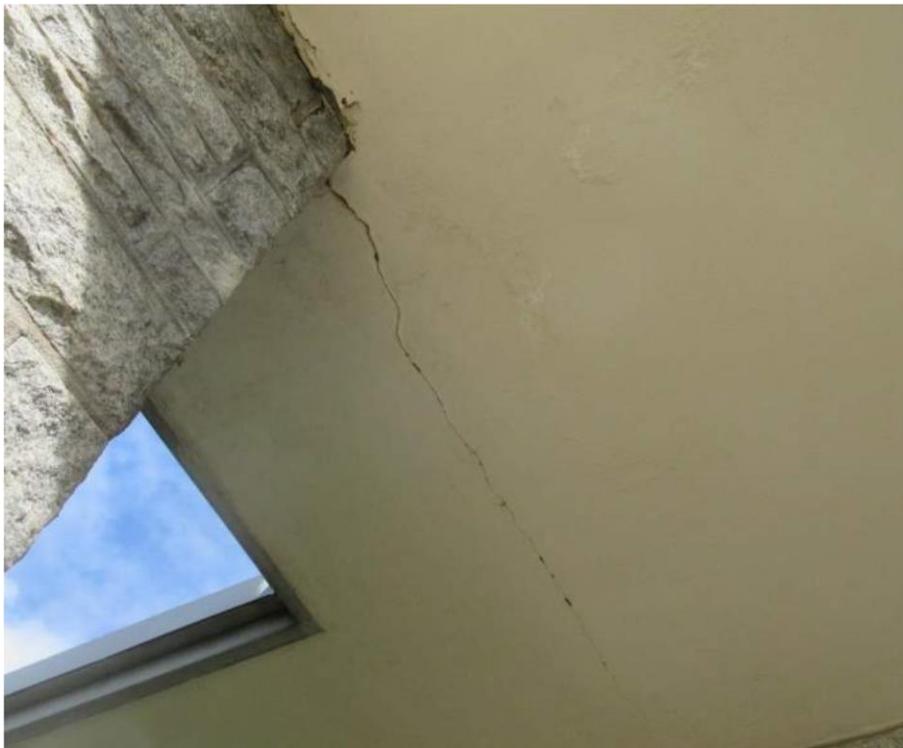
***Cracked soffit, South elevation.***

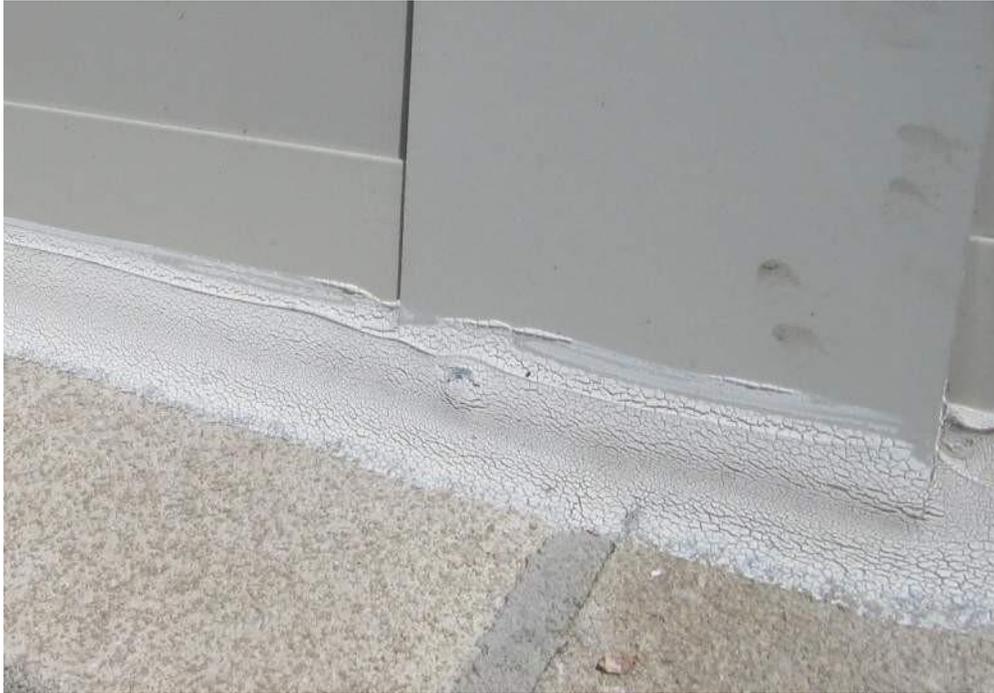
***Typical failing and crazed window perimeter sealant.***

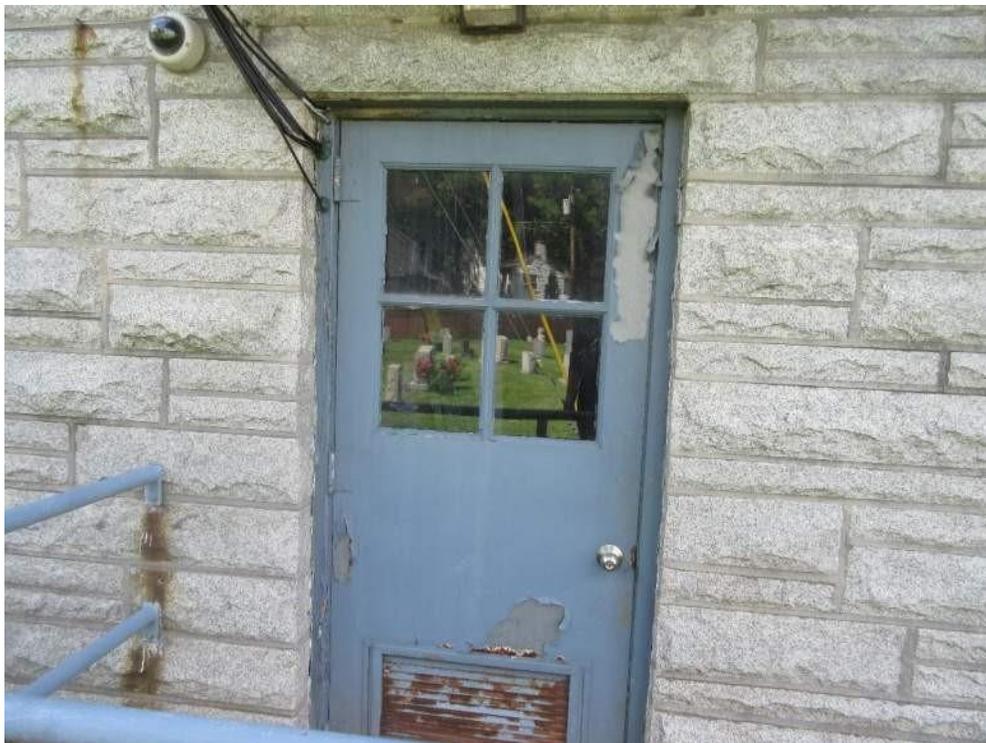
***Peeling paint and corroding metal door at North elevation.***
