EXTERIOR WALL INSPECTION REPORT  
OUR LADY OF THE ASSUMPTION CATHOLIC CHURCH

35 OLD EAGLE SCHOOL ROAD  
STRAFFORD , PA 19087

JULY 31, 2017

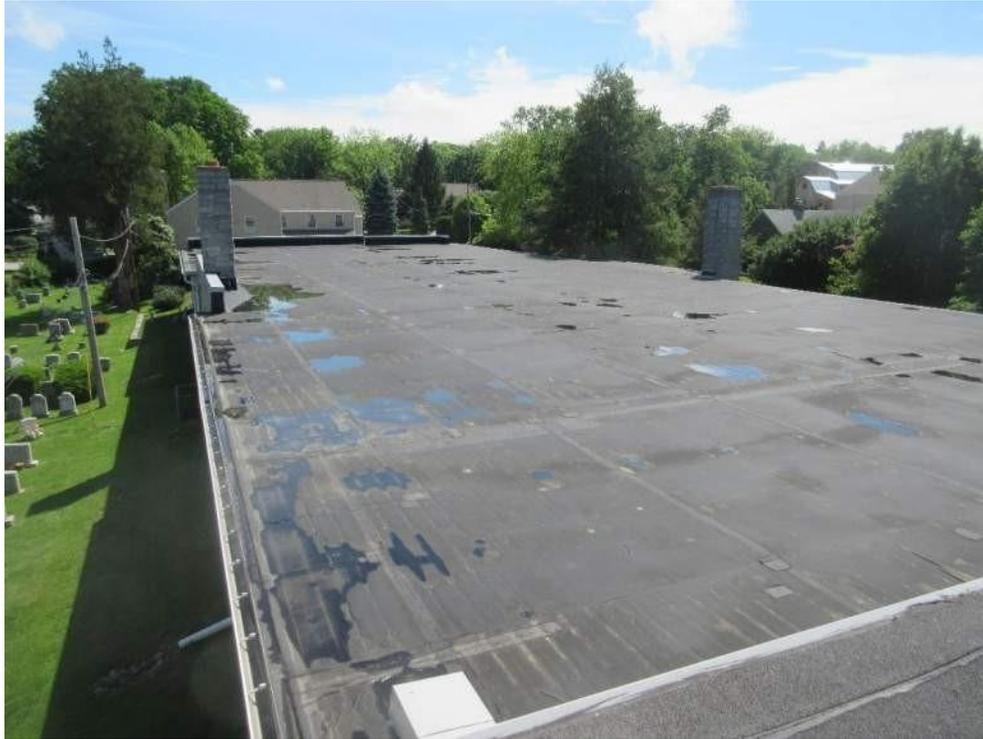
***Ponding water on EPDM roofing.***

**Recommendation:** Deteriorated joints in granite masonry should be cut and repointed within the next 2-4 years. The cracked granite should be repaired within the next year to prevent accelerated masonry deterioration. All cracks in the soffit should be routed and sealed within the next 2-4 years. All window sealant should be removed and replaced within the next 2-4 years to maintain the water tightness of the building. The metal door at the North elevation should be replaced within the next 2-4 years. O&S recommends the parish have an annual roofing inspection to maintain the serviceability of the roofing membrane.

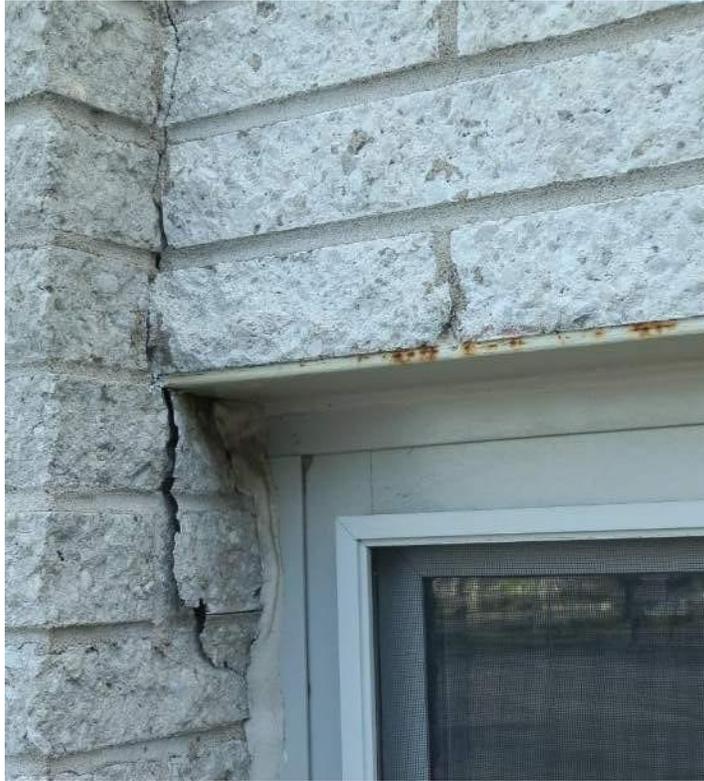
***Spalling concrete veneer adjacent to window at West elevation.***

***Recommendation:*** Spalling concrete veneer should be removed and replaced within the next year. Cracked mortar joints should be sealed within the next 2-4 years to prevent accelerated masonry deterioration. Corroded steel lintels should be scraped, primed, and painted within the next 2-4 years to extend the service life and prevent masonry deterioration. The metal awning at the West elevation should be scraped, primed, and painted within the next 5-10 years to prevent further deterioration. All failing window sealant should be removed and replaced within the next 2-4 years to maintain the water tightness of the building.

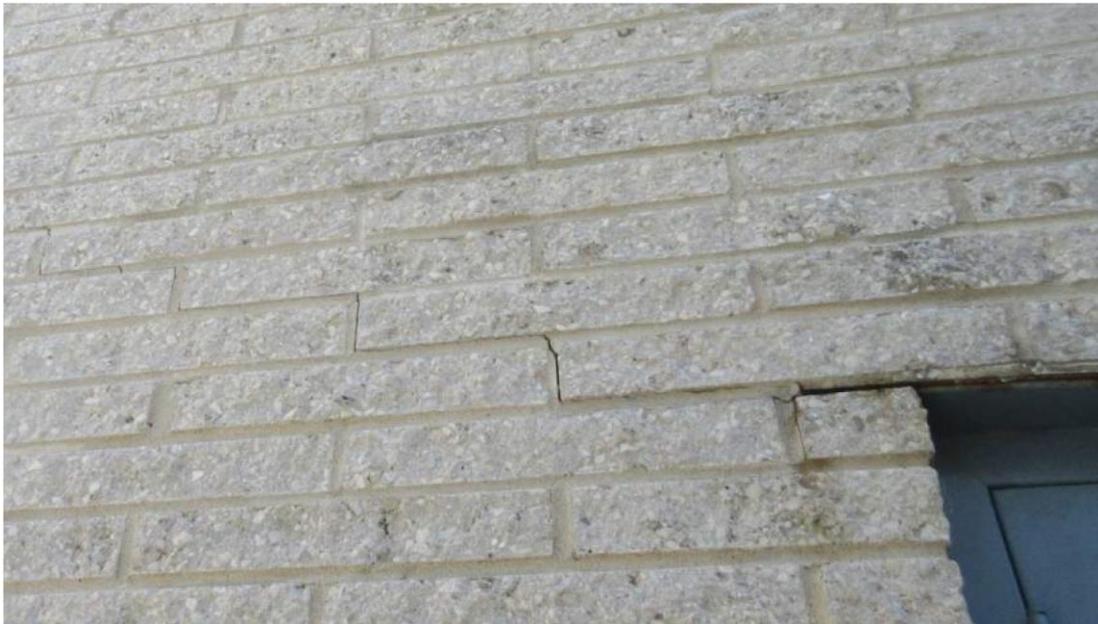
***Cracked mortar joints in concrete veneer at West elevation.***

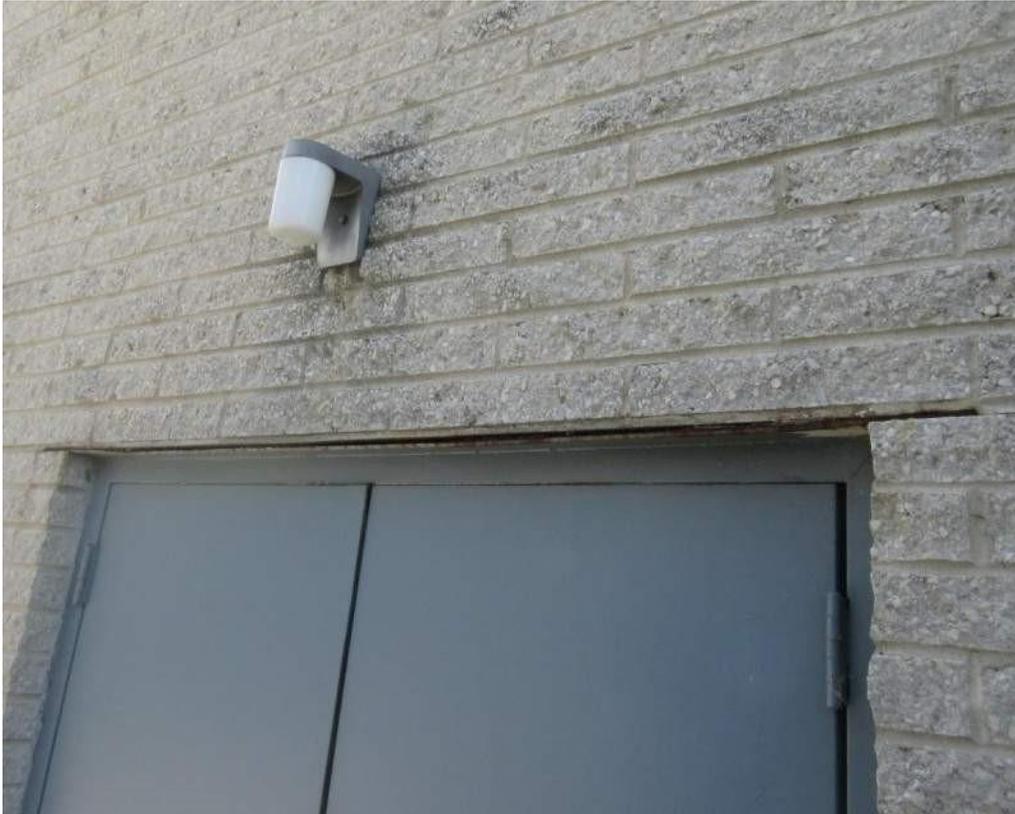
***Corroded steel lintel at door, West elevation.***

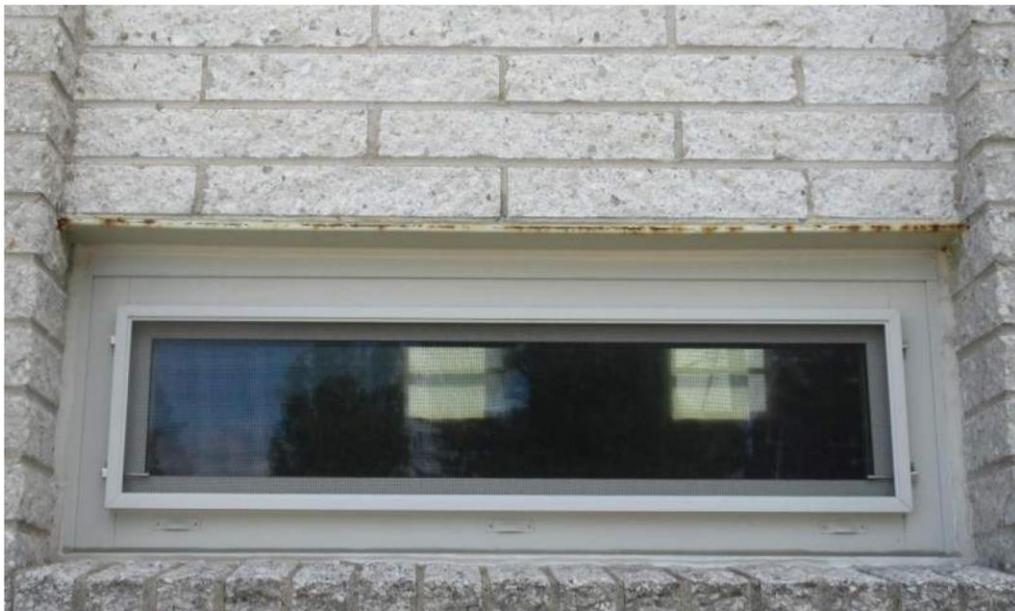
***Typical corroded steel lintel at window, West elevation.***

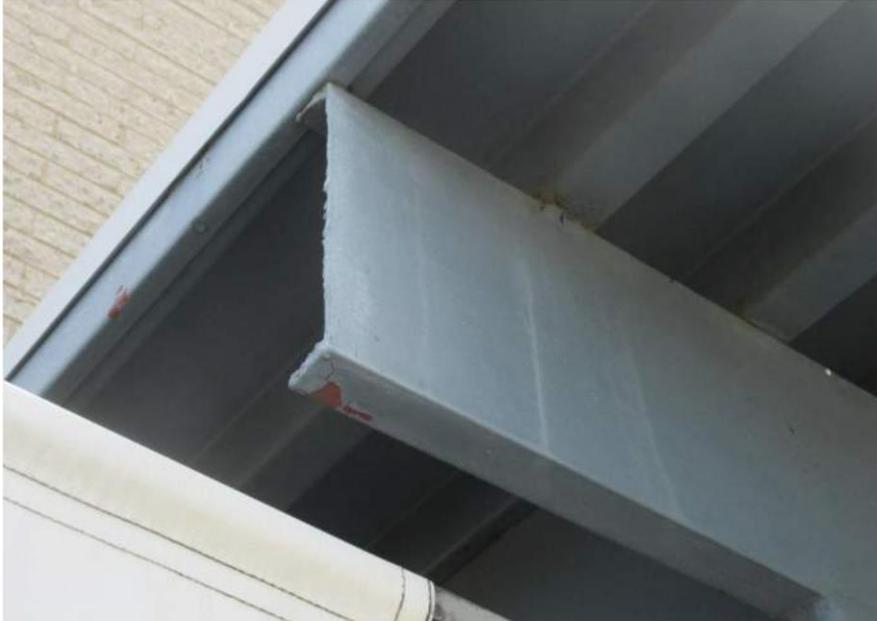
***Peeling paint and minor corrosion at metal awning at West elevation.***

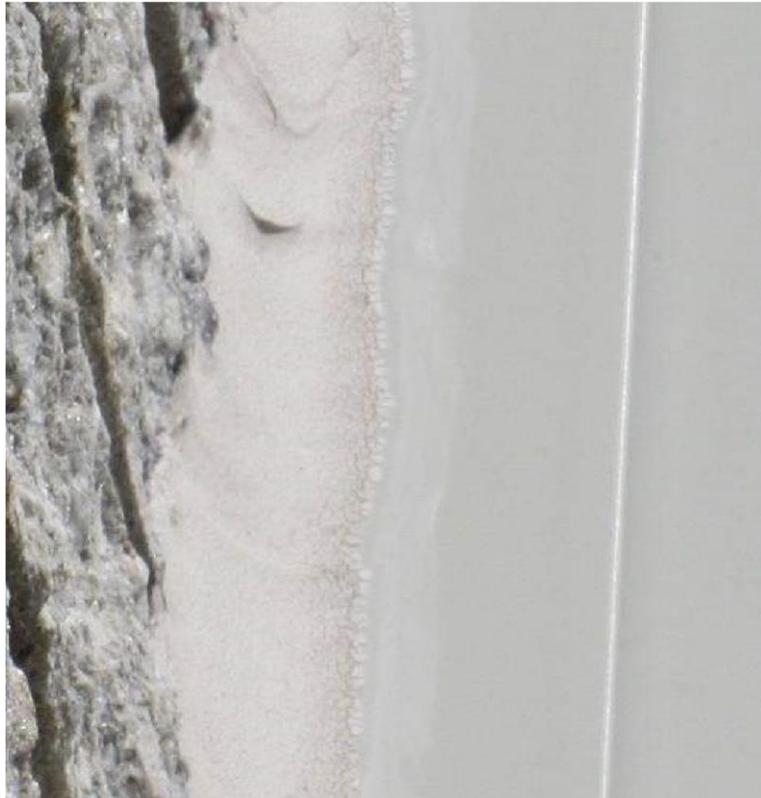
***Window sealant beginning to fail, typical throughout.***

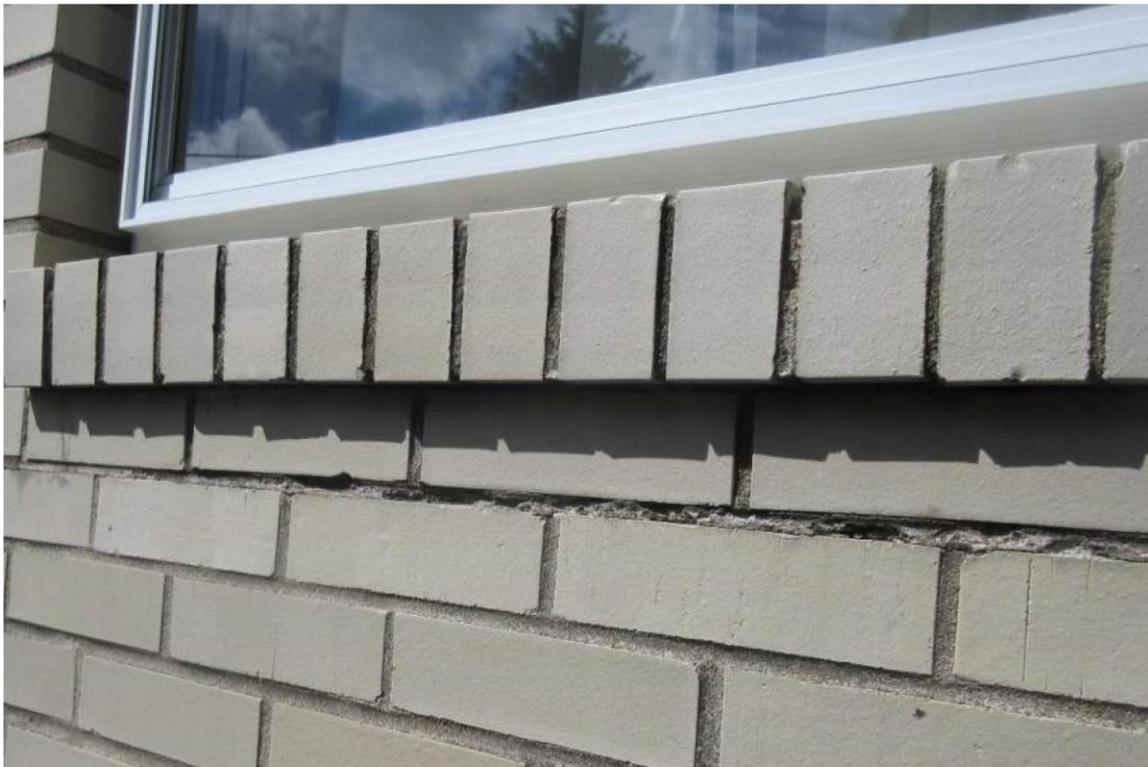
***Deteriorated mortar joints at East elevation.***

**Recommendation:** Deteriorated mortar joints should be cut and repointed within the next 2-4 years. The brick masonry at the chimney should be removed, reset, and pointed within the next year. All corroded steel lintels should be scraped, primed, and painted within the next 2-4 years to prevent accelerated deterioration of surrounding brick masonry. Failing window sealant should be removed and replaced within 2-4 years to maintain the water tightness of the building.

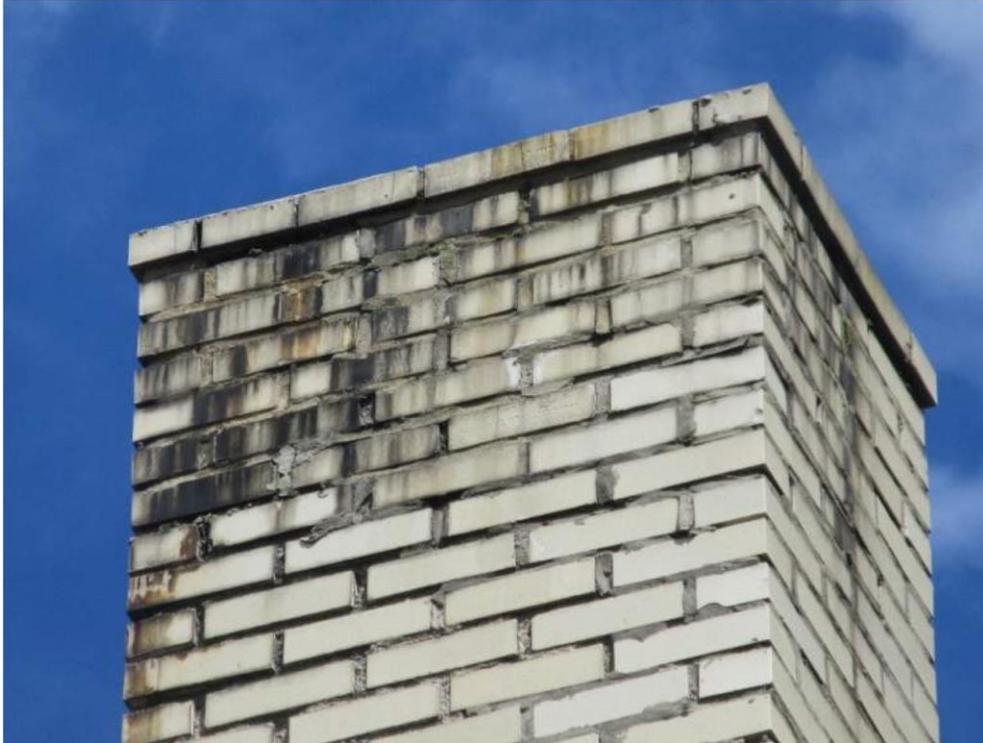
***Deteriorated mortar joints on chimney at Northeast building corner.***

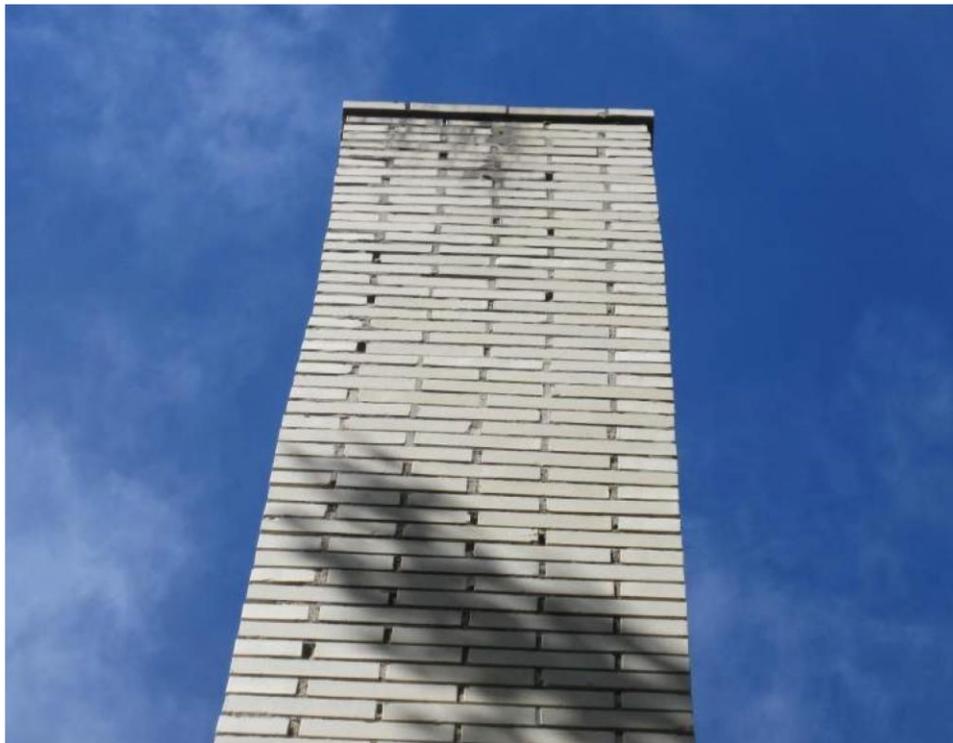
***Leaning chimney at Northeast building corner.***

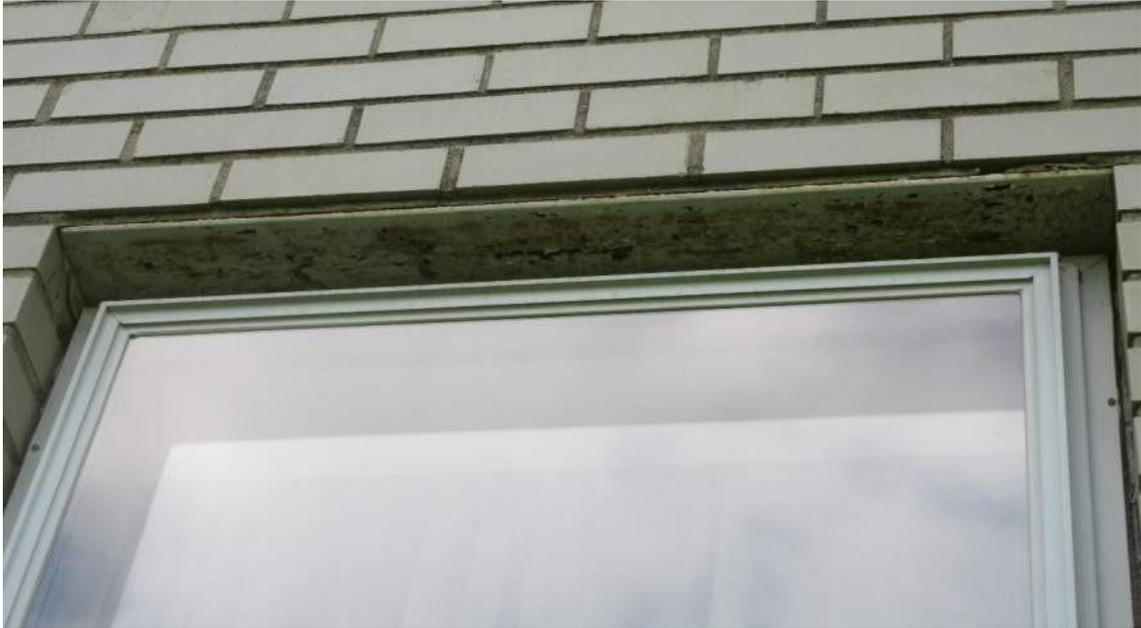
***Typical corroded steel lintel atop window.***

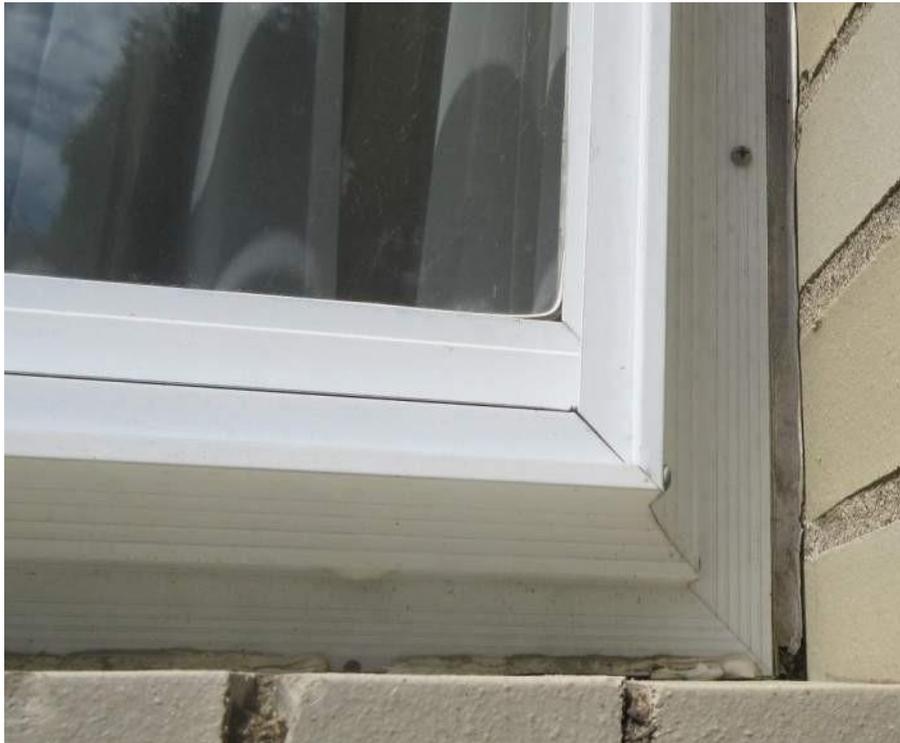
***Typical failing window sealant.***
