EXTERIOR WALL INSPECTION REPORT  
OUR LADY OF THE ASSUMPTION CATHOLIC CHURCH

35 OLD EAGLE SCHOOL ROAD  
STRAFFORD , PA 19087

JULY 31, 2017

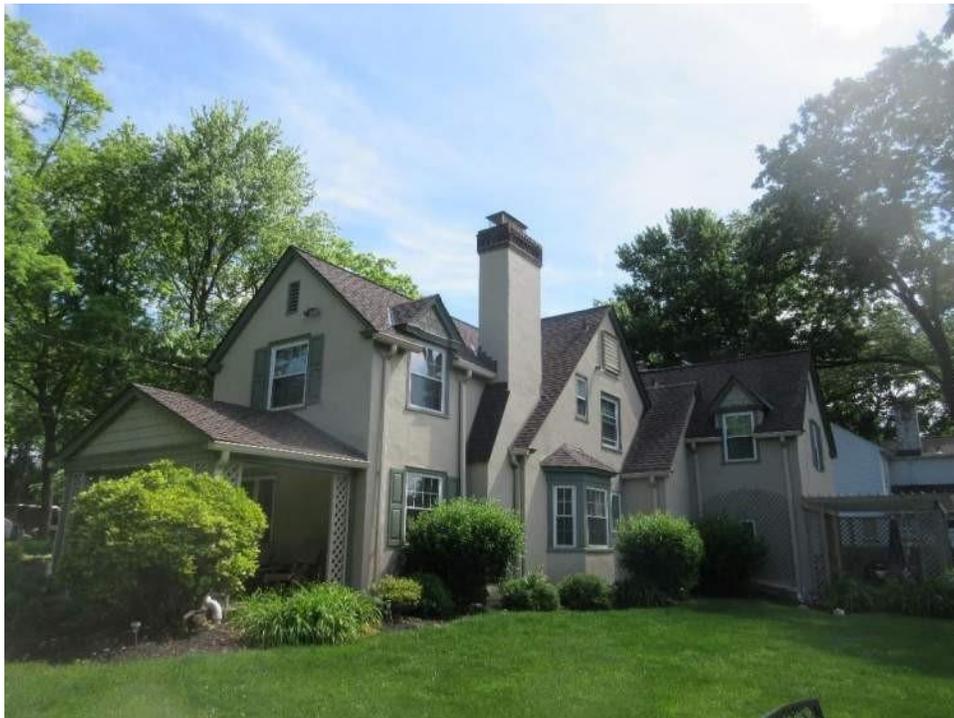
***Overall of West and South elevations.***

**Recommendations:** O&S recommends the parish have an annual roofing review and perform preventative maintenance to maintain the service life of the building.
